## **Response of AES Puerto Rico LP to EPA's September 16, 2014 Water Compliance Inspection Report**

AES Puerto Rico LP ("AESPR") hereby submits this response to EPA's September 16, 2014 Water Compliance Inspection Report ("Inspection Report"). For ease of reference, AESPR will follow EPA's Findings of the Facility Walkthrough.

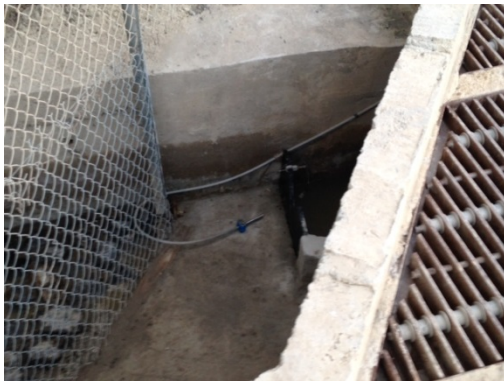
After (Picture 29)

EPA Finding f. (4): Off-site tracking of what appears to be Aggremax™ fine particles was observed at the wetlands (outfall 002). Picture 29 depicts this finding.

AESPR Response to EPA Finding f.(4) – AESPR disputes the assertion that Agremax particles were present at the wetlands or that Picture 29 depicted the presence of such particles. It is AESPR's view that what was observed was dirt.
